Manhole Inspection Summary

Manhole # S09CC2032MH

Insp Date: **7/17/06 1:20 PM**

Location Address: **5868 PIMILICO RD**

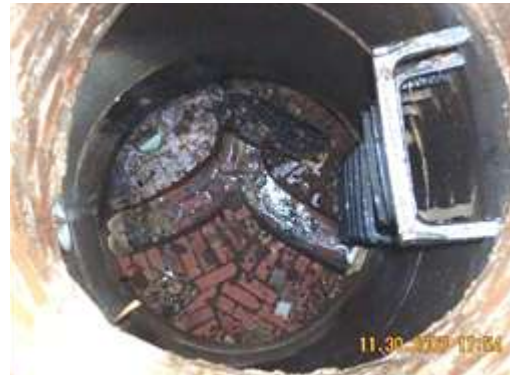
Top View

Evidence of surcharge - Bench debris.
Channel debris.

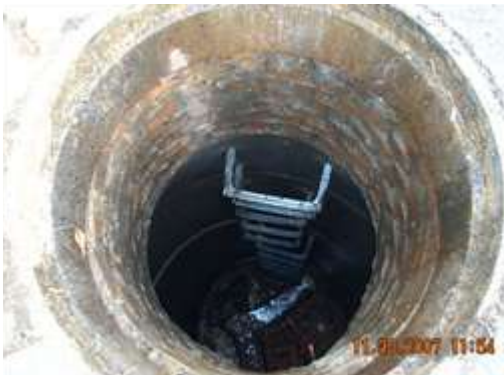
Defect

Frame leaks. Adjustment deterioration
and infiltration. Corbel and Barrel
infiltration - other side.

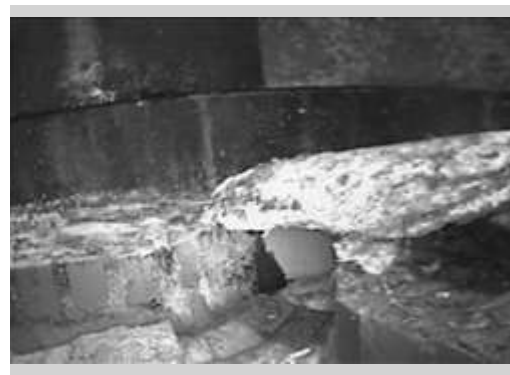
Defect

Barrel infiltration. Obstruction over the
outlet.

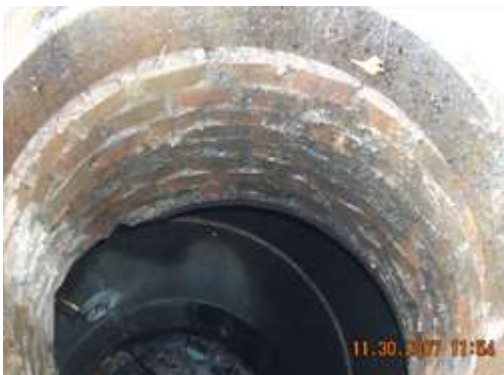
Defect

Frame leaks. Adjustment deterioration
and infiltration. Corbel and Barrel
infiltration.

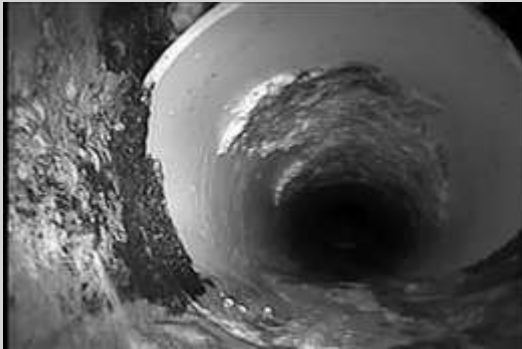
8 in. Circular Gravity Sewer Pipe Out @ 12 O'Clock

Deposits: ☐ None ☐ **Mud** ☐ Sludge ☐ **Debris** ☒ **Grease**

Silt Depth: **0** (in.) Deposits Extent: **Light**

Infiltration: **Evidence** Pipe Seal Cond: **Unknown**

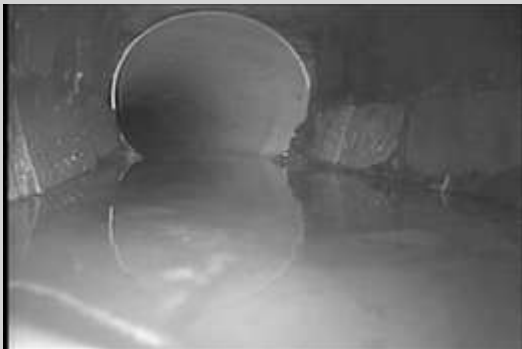
8 in. Circular Gravity Sewer Pipe In @ 3 O'Clock

Deposits: ☒ None ☐ **Mud** ☐ Sludge ☐ **Debris** ☐ Grease

Infiltration: **None** Pipe Seal Cond: **Unknown**

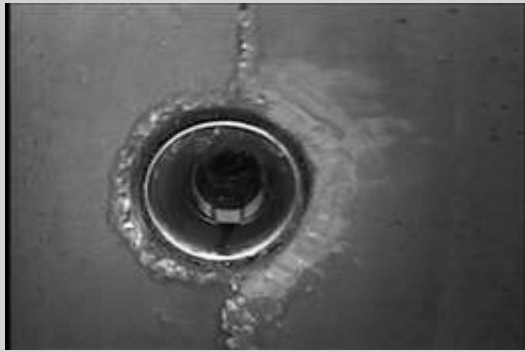
Pipe In @ 8 O'Clock

Deposits: ☐ None ☒ **Mud** ☐ Sludge ☒ **Debris** ☐ Grease

Silt Depth: **0.5** (in.)

Deposits Extent: **Light**

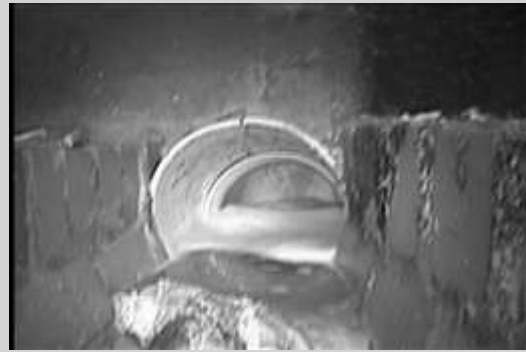
Drop In @ 8 O'Clock

Drop: **Outside** Rod and Bar

Drop Condition: **Open**
